NATIONAL PROGRAM FOR INSPECTION OF NON-FEDERAL DAMS
SPRAGUE UPPER RESERVOIR (U) CORPS OF ENGINEERS WALTHAM
MA NEW ENGLAND DIV JUN 79

SPRAGUE UPPER RESERVOIR DAM
DOCUMENT IDENTIFICATION
JUNE 1979
R103105

SPRAGUE UPPER RESERVOIR DAM

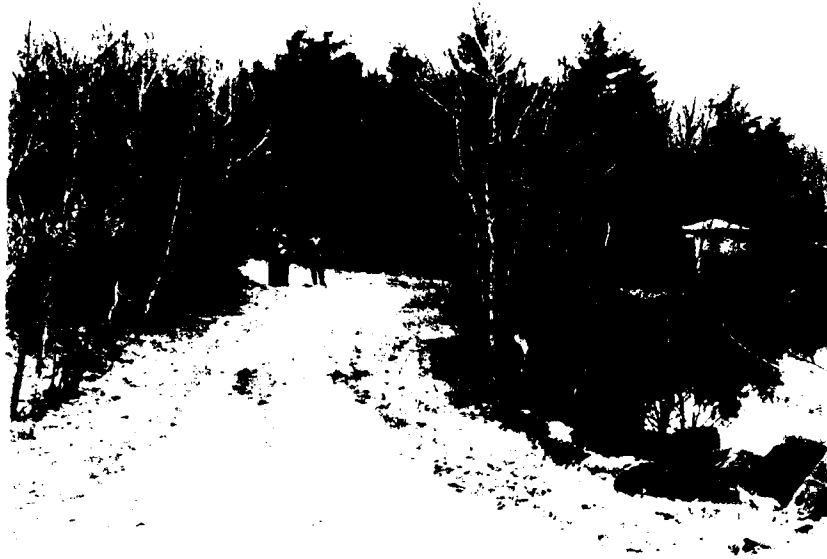
Overview from left abutment showing crest of dam

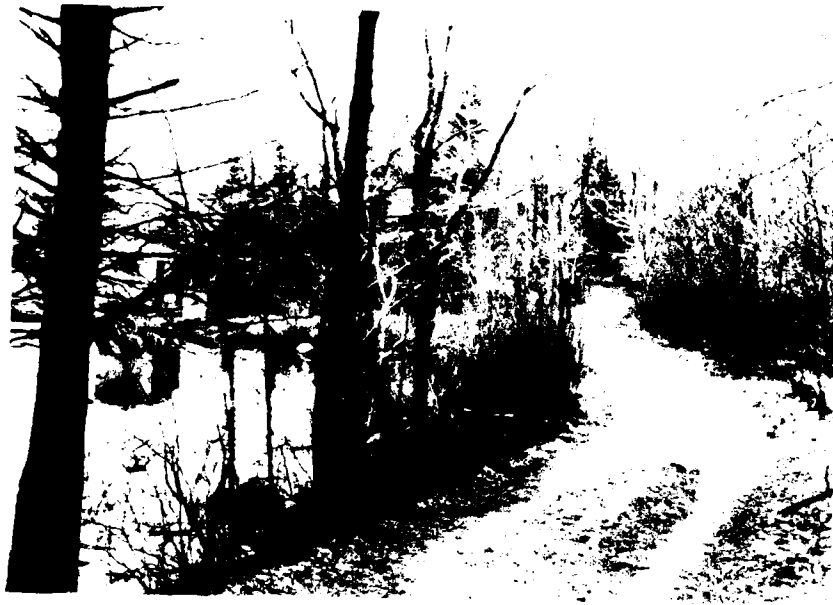
works are judged to be in very poor condition, owing to the lack of operative dewatering facilities and the presence of a sinkhole on the crest of the dam immediately above the outlet culvert. Although this depression is reported to have been there for a long time, it appears to have become significantly larger recently. This, in conjunction with the large volume of seepage, indicates that the structural integrity of the dam may be threatened. There is also extensive tree and brush growth on the crest of the dam.

1. View from right abutment showing brush and tree growth on top of dam

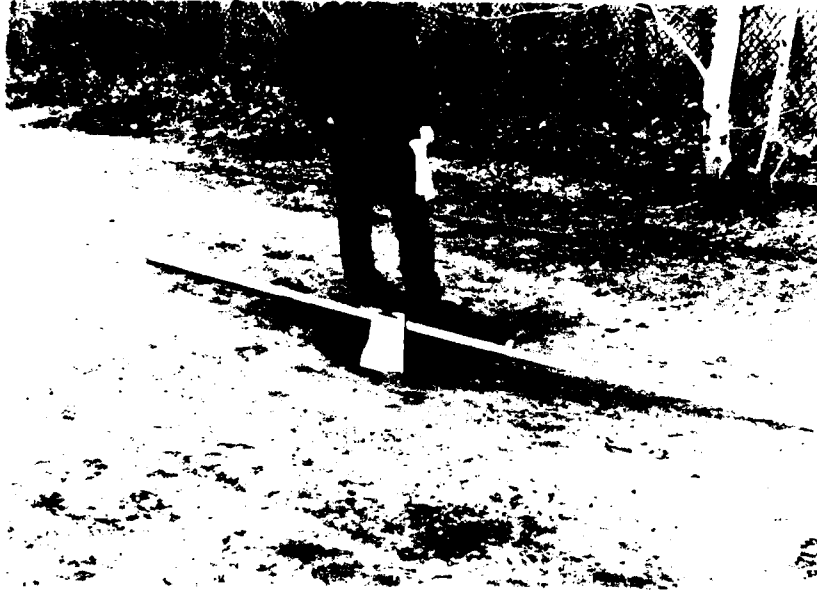
There is a small pothole or sinkhole, located at the center of the dam in line with the outlet pipe and gatehouse, or about 96 ft. left of the right abutment and 66 ft. right of the left abutment. It measures approximately 3 ft. in diameter and about 14 in. deep. Previous inspection reports have indicated that this condition has existed for several years. However, generally this condition was referred to as a slight depression. Discussions with the operator indicated that the sinkhole has appeared recently (see Photo Nos. 3 & 4, Appendix C).

3. View of sinkhole at mid-length of dam crest.

- (1) Make soils and foundation studies, and determine the cause of the sinkhole at the crest of the dam.
- (2) Determine the cause of the seepage at the toe of the dam.
- (3) Determine whether the dam should be raised and/or additional spillway capacity provided to prevent an overtopping of the dam.
- (4) Determine whether the existing outlet culvert and slide gate are repairable and of adequate size for emergency evacuation of the reservoir.
- (5) Determine whether the outlet culvert headwall requires repair.

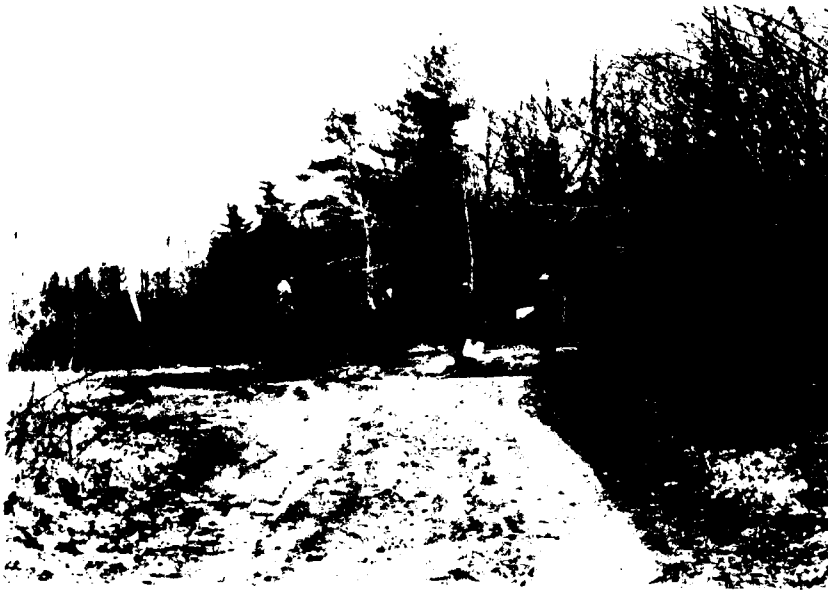
4. View of sinkhole from right abutment.

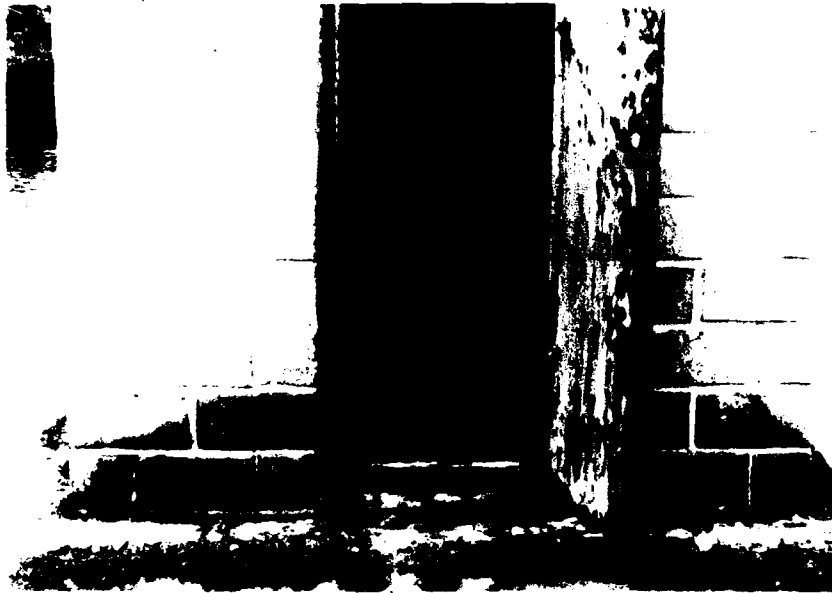
The gatehouse at the crest of the dam is over a wet well. According to an inspection report dated January 16, 1957, the upper end of the outlet pipe is covered with a plank gate set in steel channels that act as gate guides. A pre-existing valve stem made of wooden timbers rotted away and in 1957 was removed and replaced with 2 inch galvanized pipe. There is an intake stack consisting of three 12-inch vitrified tile pipes with a large copper screen installed over the intake stack. The inlet level is approximately 9 feet below the top of the Dam. The plank gate is inoperable. (See Drawings, Appendix B and Photo Nos. 7 & 8. Appendix C)

7. View of inoperable gate stem inside gatehouse.

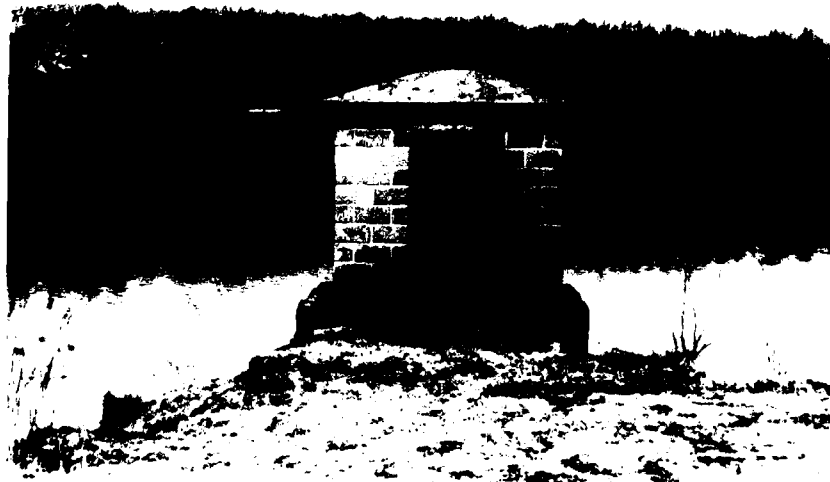
8. View of gatehouse from crest of dam.

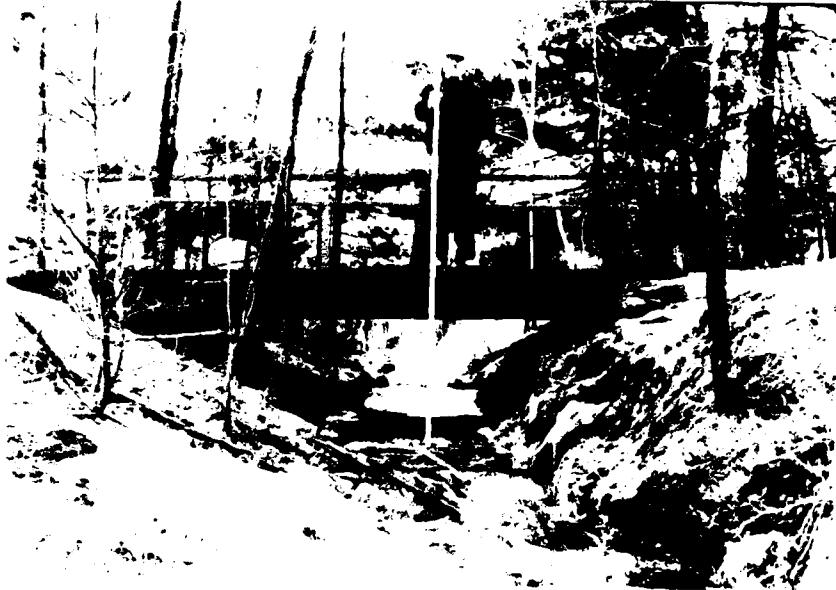
5. View of spillway channel from downstream.

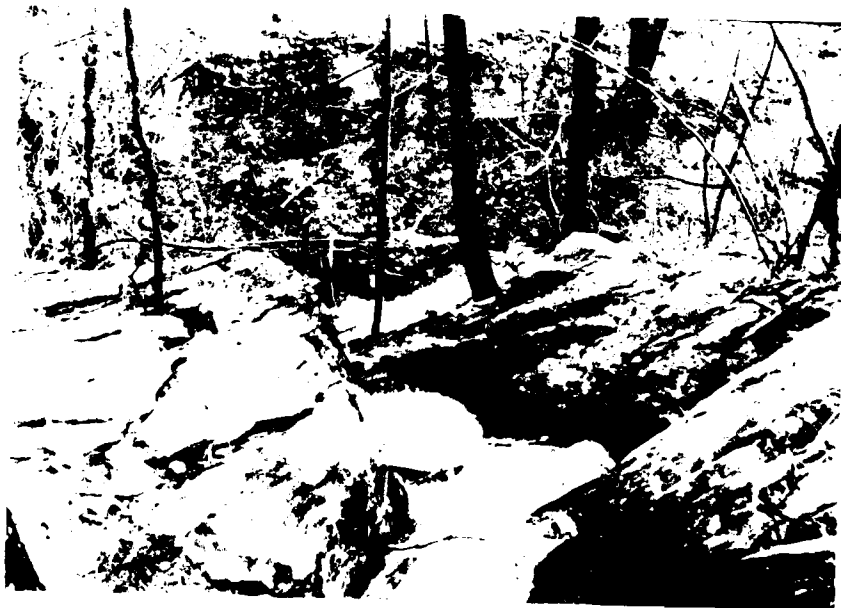
6. View of downstream spillway channel.
